# Mobile Gas Leak Detection System

**Overall Inspection Route with Leak Identification:**

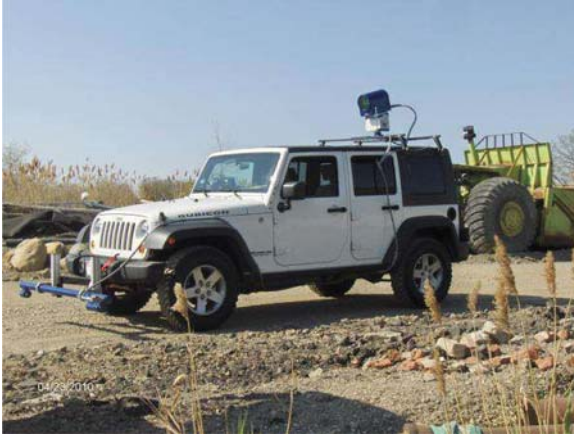
*The working principle of this methane gas leak detector is based on a pulsed beam from a diode laser which is directed at the location or area to be inspected.*

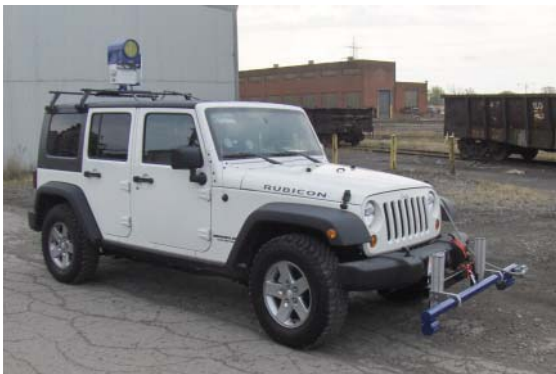
*Applications shown:*

*Marcellus Shale Well Gas Leak Detection  
Transmission Line Leak Detection*

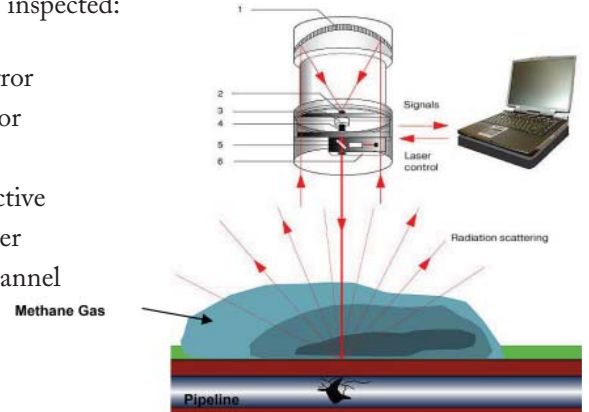
- 1 – Parabolic Mirror
- 2 – Photo Detector
- 3 – Diode Laser
- 4 – Optical Objective
- 5 – Optical Splitter
- 6 – Reference Channel

The pulsed beam from the diode laser (3) passes the optical objective (4) and is pointed at the location to be inspected. This laser beam, pointed at the pipeline and/or a leak, is reflected and the scattered reflection is collected by a parabolic (1) mirror. The laser beam passes an optical splitter (5). The main part of the beam goes through but a part of the beam is reflected and goes to the reference channel (6) consisting of a cuvette with a standardized gas sample. The photo detector (2) generates a signal which is compared to the signal from the reference channel (6).

When the laser beam passes through a methane gas cloud (leak), the laser light will be absorbed and the resulting deformation of the signal is proportional to the concentration of methane along the measuring path. The laser's wavelength of 1.65  $\mu\text{m}$  corresponds to the first absorption band of methane. The signal generated in this optical unit is processed in the analog/digital card and then analyzed with the gas leak detection software.

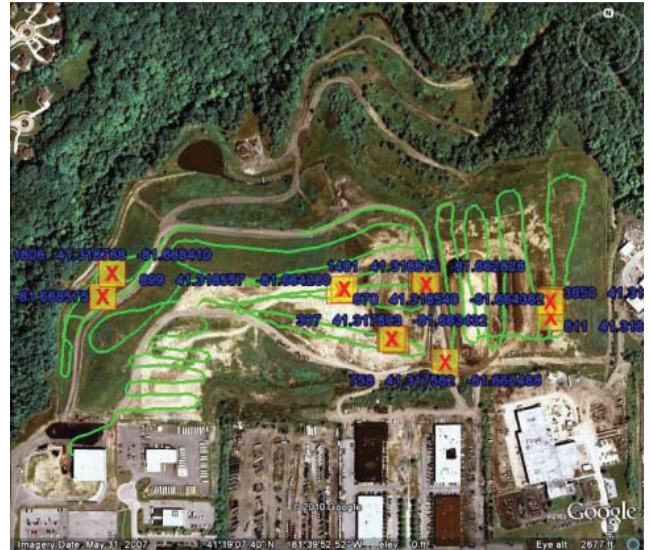
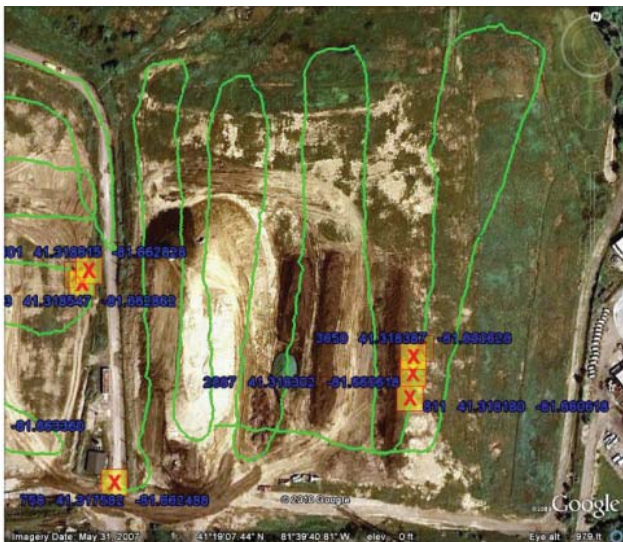
Green lines indicate inspection pathways. Yellow boxes with Red X's indicate the locations of methane detections > than 300 PPM. The actual detection levels with geoposition are in Blue.

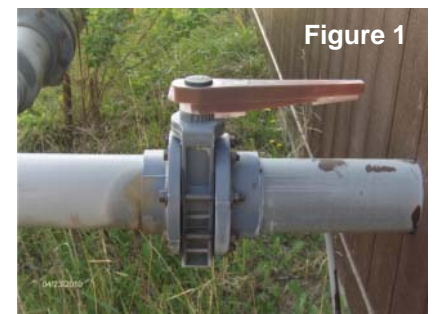
**Comments:** The detection of 758 PPM was identified as a leak on the Flare Gas Supply System. We further identified and verified the gas leak utilizing a hand held passive infrared camera. The infrared leak video and IR leak report are included as an attachment to this report. The leak is originating from the Gas House Flare Supply Pipe- 6 inch Valve Outlet at Nipple (Figure 1).

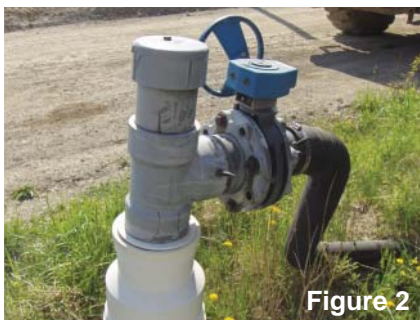
The hand held passive infrared camera also identified a leak located on a collection well head (Figure 2) that was not inspected by the mobile due to its location behind the North West corner of the Gas House. An immediate adjustment was made to the vacuum system flow valve which prevented any further loss of methane. Repair to the leaking connection is recommended to prevent the future loss and reduce the amount of ambient air entering the collection system.

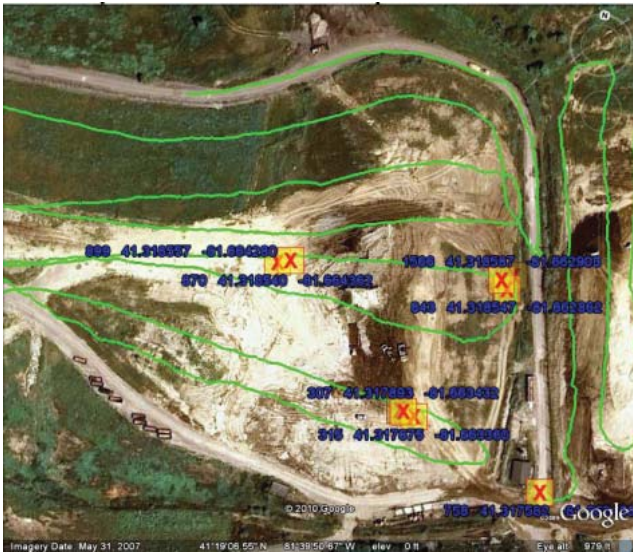
**Area with Collection System NW of Gas House - Inspection Route and Leak Identification:**

Date	Time	Latitude	Longitude	Methane Concentration (ppm*m)
4-23-10	11:32:49.20	41.318557	-81.664280	899
4-23-10	11:32:55.20	41.318540	-81.664362	870
4-23-10	11:36:01.51	41.318587	-81.662903	1566
4-23-10	11:41:43.17	41.317893	-81.663432	843
4-23-10	11:52:40.11	41.317893	-81.663432	307
4-23-10	11:52:55.01	41.317875	-81.663360	315

**Comments:** The multiple detections in this area identified three discrete areas where methane emissions were > than 300 PPM. We recommend the vacuum collection system negative pressure settings to be checked at the well heads closest to the areas, respectively. If an adjustment to the vacuum system can be made, we recommend adjustment and a reinspection of the areas. If localized well head vacuum is set at the maximum, we recommend cover maintenance followed by a reinspection of the areas.

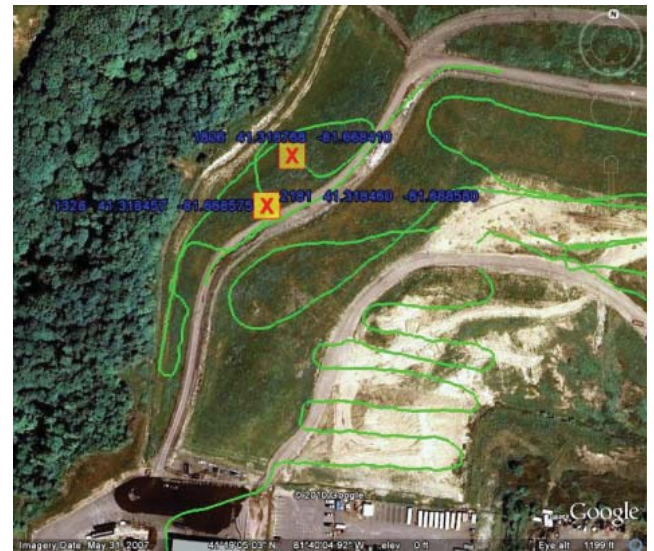
**Area with Collection System North of Entrance - Inspection Route and Leak Identification:**

Date	Time	Latitude	Longitude	Methane Concentration (ppm*m)
4-23-10	14:44:56.35	41.318768	--81.668410	1806
4-23-10	14:50:23.06	41.318460	-81.668580	2181
4-23-10	14:50:23.54	41.318457	-81.668575	1328

**Comments:** The three detections in this area highlighted two discrete locations where methane emissions were > than 300 PPM. The locations are on the West side slope of the West Roadway. We recommend the vacuum collection system negative pressure settings to be checked at the well heads closest to the areas, respectively. If an adjustment to the vacuum system can be made, we recommend adjustment and a reinspection of the areas. If localized well head vacuum is set at the maximum, we recommend cover maintenance followed by a reinspection of the areas.
